The Oil Pressure Gauge

by Jim Lunson

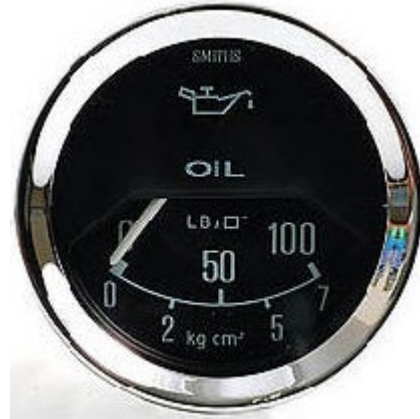
In discussing the roll of oil level in the engine and how it protects the moving parts of the engine brings up an interesting factor as it relates to one of the gauges on the dashboard. This gauge is the oil pressure gauge in all our MG cars. This gauge shows a pressure in pounds per square inch (psi). In a normal operating engine usually reads somewhere between 50 and 80 psi. What does this reading indicate?

One of the passages that carry this oil from the pump to the oil filter has a branch in it. This branch line connects to a rubber hose on the side of the engine. This hose is then connected to a small metal tube (1/8") on the firewall that goes all the way across the car and connects onto the gauge in the dashboard. This passage is sealed at the gauge so no oil flows through it, but when hooked up with the gauge, measures the pressure that the oil pump is producing as it pushes the oil to all these other spots. That is the gauge we can see and read.

So a pressure reading on the gauge of 50 to 80 psi means the oil flowing through the engine is being pumped at this pressure. A lower pressure (20 or less) signifies that either the pump is not working very well or there is a clog in the system not permitting oil to flow as it should. Either case is a sign that something in the engine needs immediate attention or damage could occur. Only when the engine is idling and the pump is not spinning very fast should the pressure drop. That is the function

One maintenance item that is important for our MGs and an item often overlooked is the small rubber hose noted above that connects the oil pump output to the metal tube that feeds across to the gauge. The small metal tube across the car to the gauge will last a long long time without concern, but this short hose (about 12" long and 1/2" diameter needs to be checked, as with any rubber item, it will deteriorate over time. And one of the problems with this hose is that it is under the same 50 to 80 psi that the pump is producing which is high for a rubber hose (about 5-6 times the pressure on a radiator hose for example), and a blowout failure of this hose in an operating engine will allow the oil pump to quickly suck out all the oil in the engine out and spray it all over the engine bay. So check this hose often. A problem with checking this hose is that the replacement hoses sold by the parts distributors are beautiful stainless steel mesh covered ones that looks great but prevent you from seeing at the condition of the rubber hose behind the shiny mesh. You need to see the rubber to see if it is deteriorating.
